Pawe H. MALINOWSKI, Davi Silva De VASCONCELLOS, Fabienne TOUCHARD, Wiesaw M. OSTACHOWICZ, Laurent BERTHE, Pedro Pascual GONZALEZ, Laurence CHOCINSKI-ARNAULT - Study of plant fibre composites with damage induced by laser and mechanical impacts - Composites Part B: Engineering - Vol. 152, p.209-219 - 2018

Study of plant fibre composites with damage induced by laser and mechanical impacts

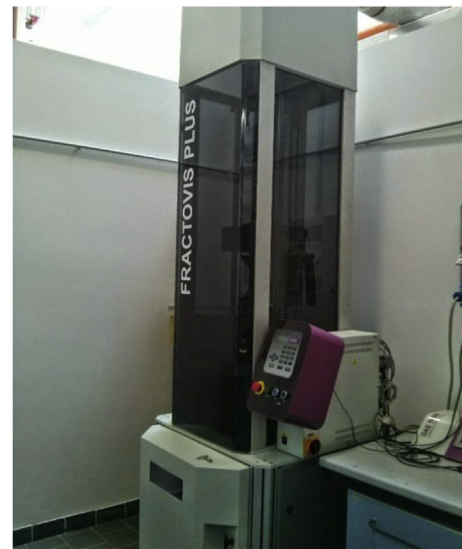
Fig. 6. Mechanical impact test stand.

The investigated samples were impacted by either a falling dart (Fig. 6) and a laser beam (Fig. 7). The mechanical impacts were performed at a velocity below 2 m/s to simulate the typical impact on

Fractovis Plus from CEAST (Pianezza - TO, Italy). The specimens were tested at energies in the range from 1 to 5J. The falling dart mass was constant (1.9265 kg), and the impact energy was changed by changing the impact height. The impact head was hemispherical, 12.7 mm in diameter. Samples damaged with mechanical impacts are coded with an additional 'M' (WA-M, TWA-M, BC3-M, etc.). The laser impact (laser shock) technique is a method that allows to achieve high levels of load inside the materials. It can be used for damage threshold analyses and allows, for example, the simulation of space debris and meteoroids impacts [20], assessment of adhesive bonds quality [21], or fibre/matrix interface study [22]. The laser beam causes the sublimation of the matter on sample surface, and the plasma created induces a reaction force in the form of a pressure shock wave that propagates through the material, thus applying a high tensile loading state (Fig. 8). All the samples were tested at six different laser shock intensities, keeping constant the shock beam diameter (6 mm) and the pulse duration (10.2 ns). Samples tested by the laser are coded with an additional 'L' (WA-L, TWA-L, BC3-L, etc.). Representative samples after each type of impact testing are reported in Fig. 9.
